SCHOOL DISTRICT OF POYNETTEFacility Assessment

This facility assessment is the outcome of work completed by J.H. Findorff & Son Inc. for the School District of Poynette between January and April 2017. The facility assessment documents the physical condition of existing buildings, sites, and systems. Plunkett Raysich Architects completed the review of the educational adequacy of the three buildings.

A. OVERALL BUILDING SUMMARY		
Facility Location:	307 Bullen Road	
	Arlington, WI	
	53911	
Original Construction:	Original Construction: 1953	
Additions/Renovations:	Addition: 2001	
Building Statistics:	Building Footprint = 13,992 SF	
	Building Gross Square Footage =13,992 GSF	
	Site Parking Spaces = 10 Spaces	
	Site Area = 5.1 Acres	
Number of Levels:	One Level Above Ground	
	Mechanical Spaces on Lower Level	
Building Overview/Useage:	Early Childhood - Kindergarten Grade Levels Current Year Enrollment: 74	
Construction Type (Structural):	Addition: 4' Concrete Frost Walls, Wood Shear Wall Prefabricated Wood Truss	
Construction Type (Exterior):	Brick Veneer Walls, Fiberglass Asphalt Shingles Roof

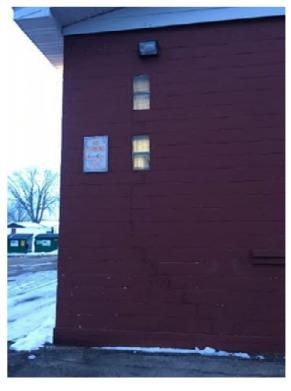
Photo 3. West wall of Gymnasium. Crack visible entire height of wall. Multiple exterior cracks visible have been caulked. Recaulk as needed (Priority 0).

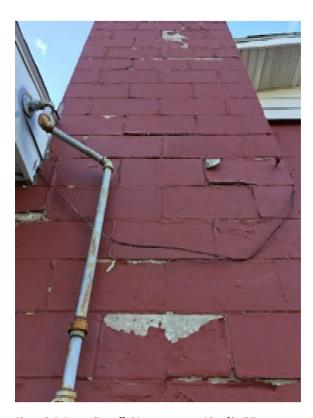
Photo 6. Paint peeling off chimney on east side of building. Cracking throughout mortar joints. Walls should be structurally analyzed to confirm integrity. If sound, remove finish, tuckpoint, and repaint.(Priority 0).

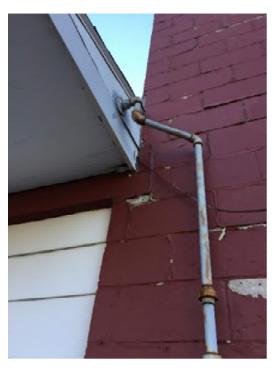
Photo 7. Paint peeling off chimney on east side of building. Cracking throughout mortar joints. Walls should be structurally analyzed to confirm integrity. If sound, remove finish, tuckpoint, and repaint.(Priority 0).

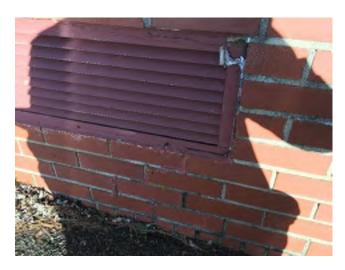
Photo 11. Damage to grille and significant mortar cracking. Route out caulk and recaulk or tuckpoint. (Priority 0).

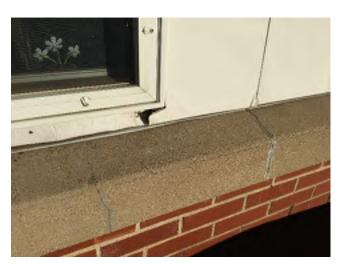
Photo 12. Failed caulk and cracking at cast stone sill. This condition is consistent throughout the original building exterior. Repair joints and caulk. (Priority 0).

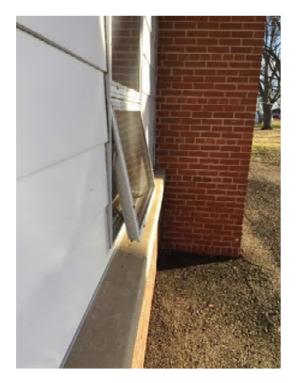
Photo 18. Operable exterior windows on original building. Thermal imaging displayed significant energy loss at these locations. Replace with energy efficient windows. (Priority 0).

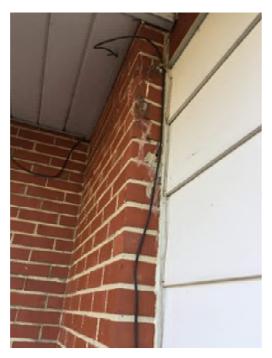
Photo 19. Significant deterioration of masonry veneer on building's west elevation.

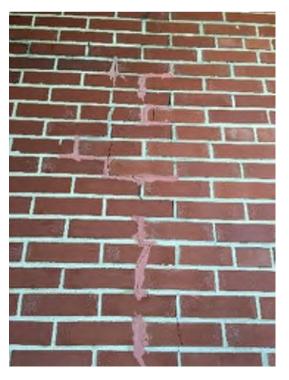
$\label{eq:photo-20.} Photo 20. Significant deterioration of masonry veneer on building's west elevation.$

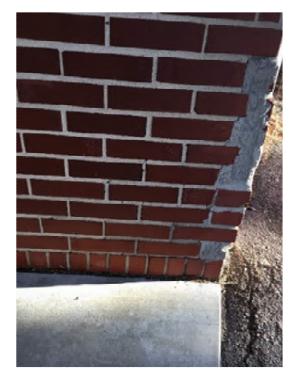
Photo 21. Significant deterioration of masonry veneer on building's west elevation.

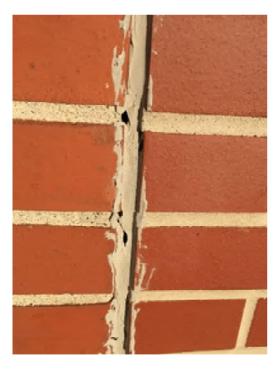
Photo 24. Caulking of vertical control joints on 2000 addition have failed. Recaulk. (Priority 0).

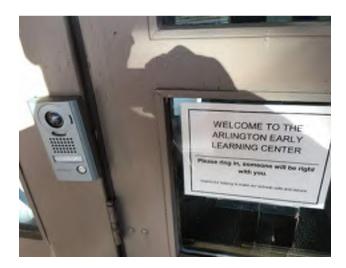
Photo 26. Main entrance. Camera/Call button unit makes this entrance secure. No direct entry to vestibule.

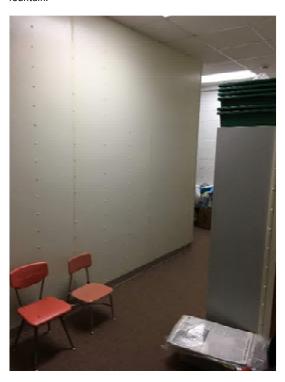
Photo 28. Girls and Boys changing rooms on east side of gymnasium do not appear to be heavily used. Walls were installed after this space was originally constructed. Space did not appear to have adequate warm air supply.

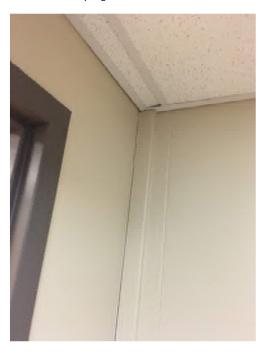
Photo 30. Crack at building tie-in location between 2012 addition and 1968 addition (2^{nd} floor).

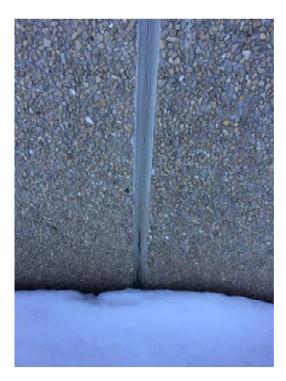
Photo 22. Caulk at precast is failing. Remove and replace caulk throughout 2001 addition. (Priority 0)

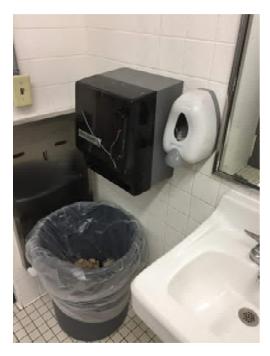
Photo 82. Paper towel dispenser in one bathroom has been damaged, should be replaced.

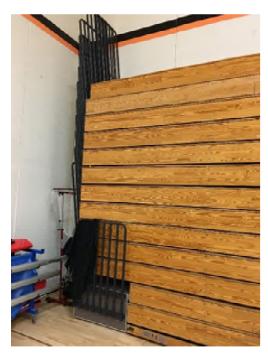
Photo 92. Bleachers in Don Kerr Gym should be replaced at end of useful life. (Priority 4)

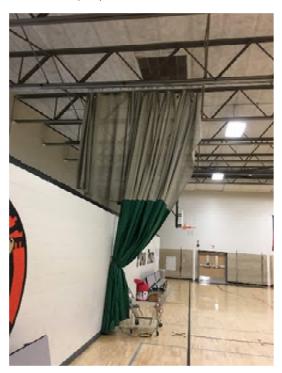
Photo 98. Divider curtain in Auxiliary Gym in fair condition.

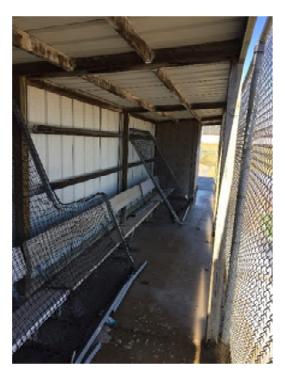
Photo 11. Baseball field dugouts are in fair condition. Consider upgrading.
