SCHOOL DISTRICT OF POYNETTEFacility Assessment

This facility assessment is the outcome of work completed by J.H. Findorff & Son Inc. for the School District of Poynette between January and April 2017. The facility assessment documents the physical condition of existing buildings, sites, and systems. Plunkett Raysich Architects completed the review of the educational adequacy of the three buildings.

A. OVERALL BUILDING SUMMARY		
Facility Location:	307 Bullen Road	
	Arlington, WI	
	53911	
Original Construction:	Original Construction: 1953	
Additions/Renovations:	Addition: 2001	
Building Statistics:	Building Footprint = 13,992 SF	
	Building Gross Square Footage =13,992 GSF	
	Site Parking Spaces = 10 Spaces	
	Site Area = 5.1 Acres	
Number of Levels:	One Level Above Ground	
	Mechanical Spaces on Lower Level	
Building Overview/Useage:	Early Childhood - Kindergarten Grade Levels Current Year Enrollment: 74	
Construction Type (Structural):	Addition: 4' Concrete Frost Walls, Wood Shear Wall Prefabricated Wood Truss	
Construction Type (Exterior):	Brick Veneer Walls, Fiberglass Asphalt Shingles Roof

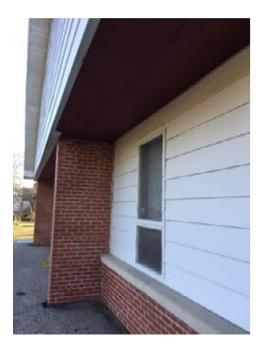
Photo 9. East side exterior wall and painted wood soffit.

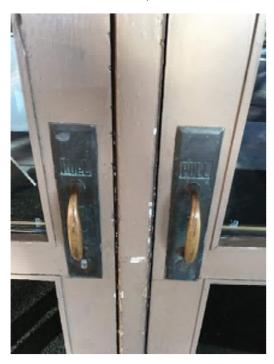
Photo 27. Pull handle hardware at main building entrance.

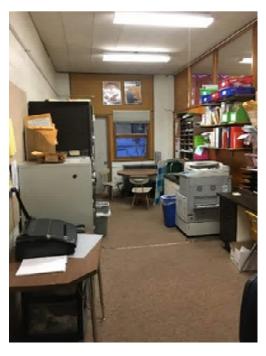
Photo 2. Main Office. Located a few doors down from the main entrance. This is a security concern.

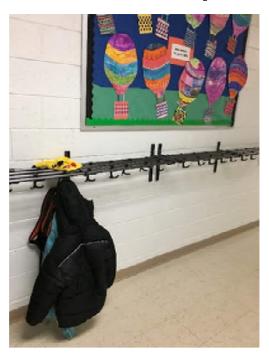
Photo 7. Student coak hooks in 1954 original building hallway.

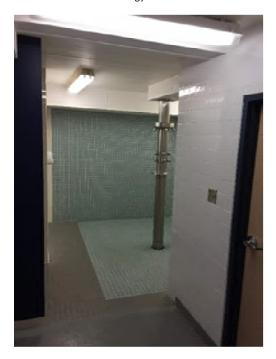
Photo 65. Multiple flooring tile colors are installed in the shower area of the boys locker room.

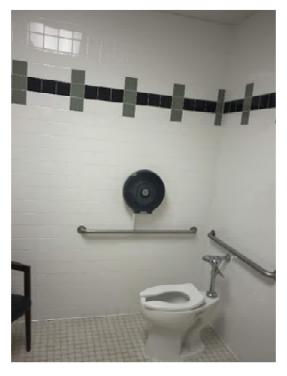
Photo 79. Toilet accessories are in good condition.

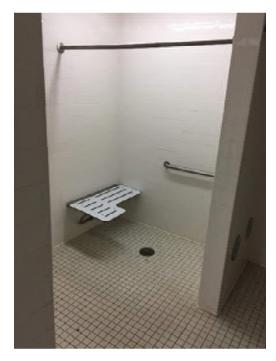
Photo 80. Toilet accessories in 1963 are in good condition

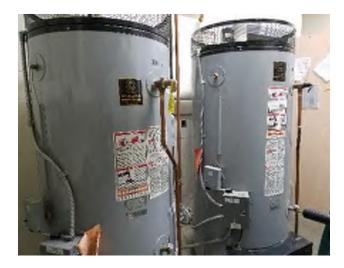
Photo 1. High School Water Heaters

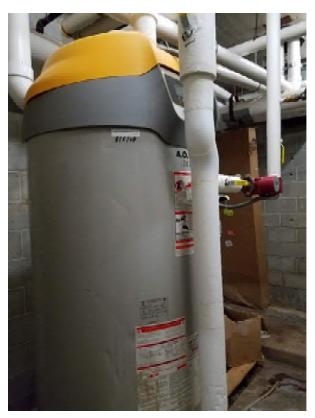
Photo 2. High School Water Heater

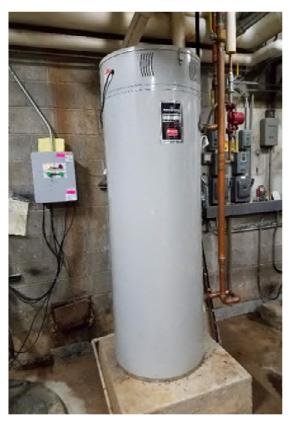
Photo 3. High School Water Heater

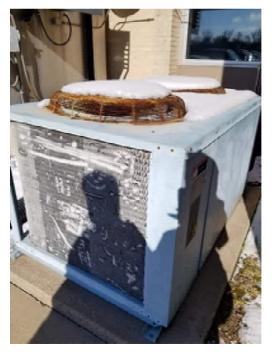
Photo 7. High School Condenser Unit for AHU

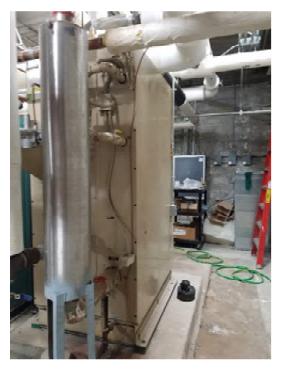
Photo 9. Fulton Boiler

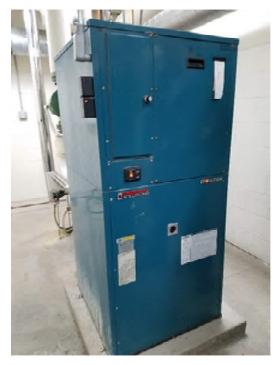
Photo 10. Thermal Solutions Boiler

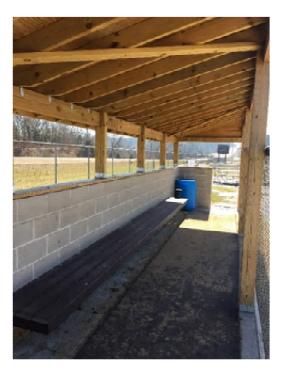
Photo 8. Southern softball field dugouts. CMU block and wood structure in good condition.
